TELETEST™ FOCUS+ IN DESERT ROAD CROSSING INSPECTION APPLICATIONS

Eddyfi Technologies inspected a below-grade pipeline at road crossings in the Sahara desert, North Africa with the Teletest™ FOCUS+ guided wave system.

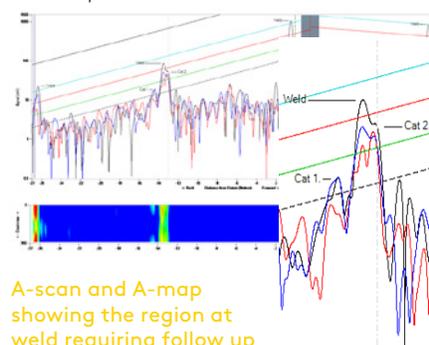
A particular region highlighted in the scan above was identified for follow-up. It is clear from the A-scan that the girth weld signal is very irregular when compared to the other three remaining welds. A category 2 and a category 1 indications were also noted adjacent to the suspect weld.

A-scan and A-map showing the region at weld requiring follow up

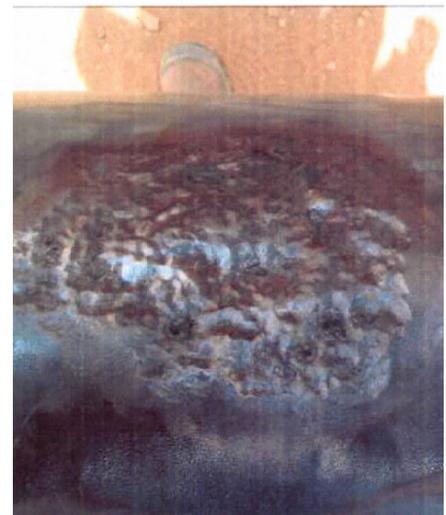
The customer excavated this region to find extensive external corrosion around the weld and in the region adjacent to it. After performing manual UT, the remaining wall thickness was found to be 5.8 mm (0.23 in) from the nominal 9.6 mm (0.38 in). The road crossing was subsequently decommissioned and production flow rerouted through an alternative crossing.

A close up of one area of corrosion identified adjacent to weld
