# TELETEST™ FOCUS+ IN CORROSION UNDER INSULATION APPLICATIONS

The Teletest FOCUS+ system is a guided wave non-destructive testing (NDT) technique developed to screen pipe-work for metal loss damage.

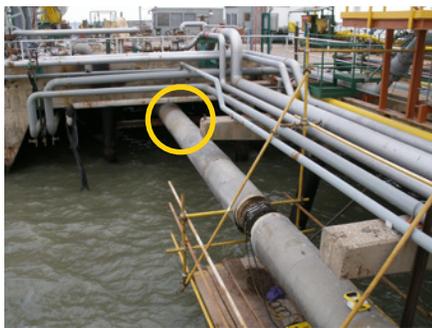
Figure 1 Location of anomaly area highlighted in Figure 2

Several anomalies were identified during the inspection and followed up while operators were still on-site. The first identified anomaly was located during the opening shot of the inspection—this was of utmost interest to the customer as the location was difficult to access as seen in Figure 1. An anomaly classified as medium priority was identified approximately 3 m (9.8 ft) from the tool position (Figure 2).

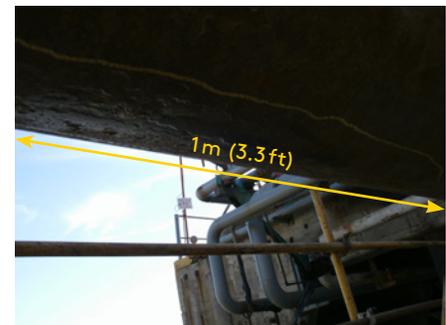
The area of interest was directly above water, so an access platform had to be erected to follow up. When the insulation was removed, the inspection team identified external corrosion at the 180° position in Figure 3. This area of corrosion was approximately 1 m (3.3 ft) long with a wall loss of 35 %.

Figure 3 Corrosion detected at 180°
