AIDING RECYCLED ALUMINUM INITIATIVES IN AUTOMOTIVE MANUFACTURING

Investigate blockage in recycled aluminum slurry system featuring long lengths of complex horizontal, vertical, and curved pipework

Custom inspection robot adapted to navigate and perform remote visual inspection internally, without dismantling recycling system

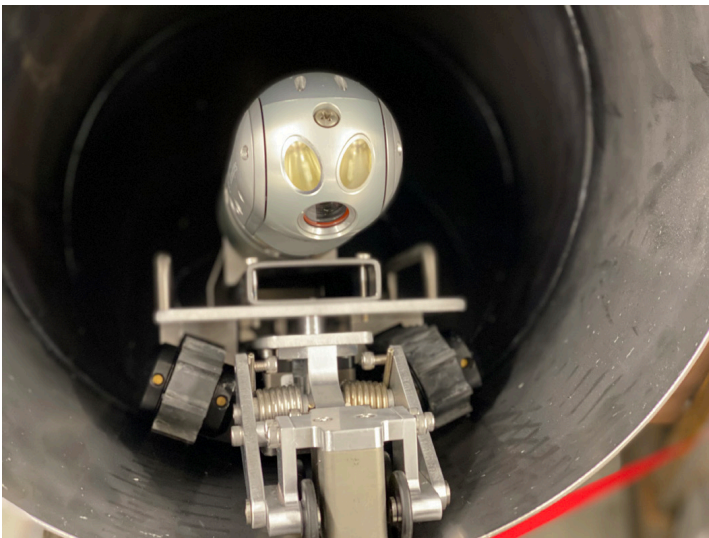
In-house custom system performance verification

The adjustable height magnet tray ensured sufficient magnetic adhesion for vertical travel. The operator could adjust lift-off, or air gap, between the magnet tray and pipe wall as needed. The magnetic balance cart also increased adhesion while climbing the inside vertical radius of the scrap metal chute. The custom solution was validated through initial mechanical modelling techniques to simulate the transitions and later by an in-house test apparatus constructed with the specified segmented elbow.

- Adjustable height magnet tray
- Magnetic balance cart located in front of the crawler to support climbing inside the vertical radius of the segmented elbow
- Angled track mounts for 400- and 460-millimeter (16- and 18-inch) internal diameters
- Swivel tether connection to support horizontal-to-vertical and vertical-to-horizontal transitions.

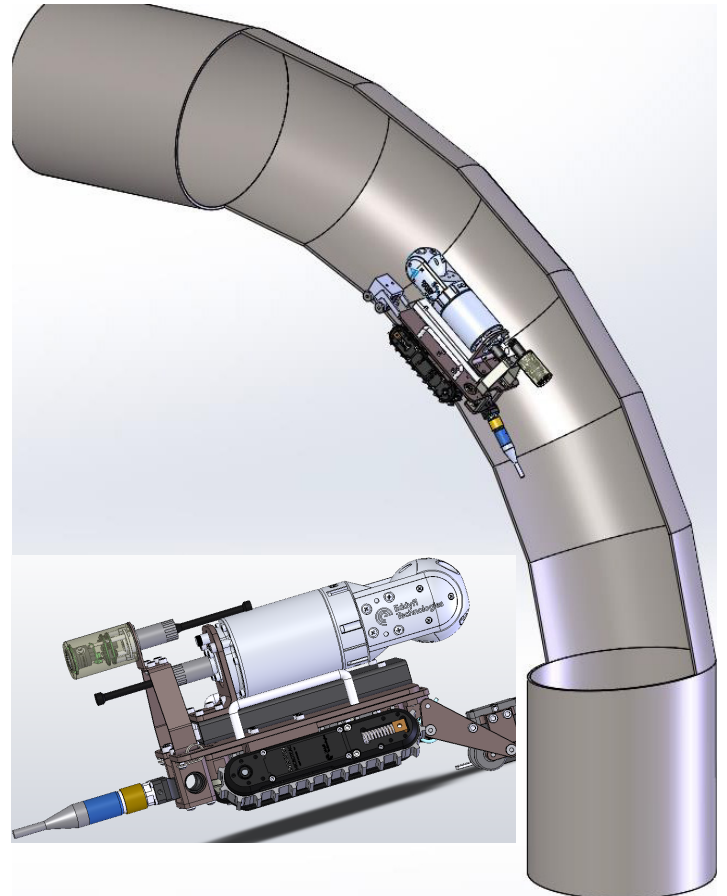
The vehicle provided real-time visual data of where the blockage issue was, without needing to dismantle the entire recycling system, and provided clear information for informed decisions.
