The challenge to asset owners and operators is to use new systems to reduce out of service time during inspection and improved inspection schedules

Increasing inspection activity

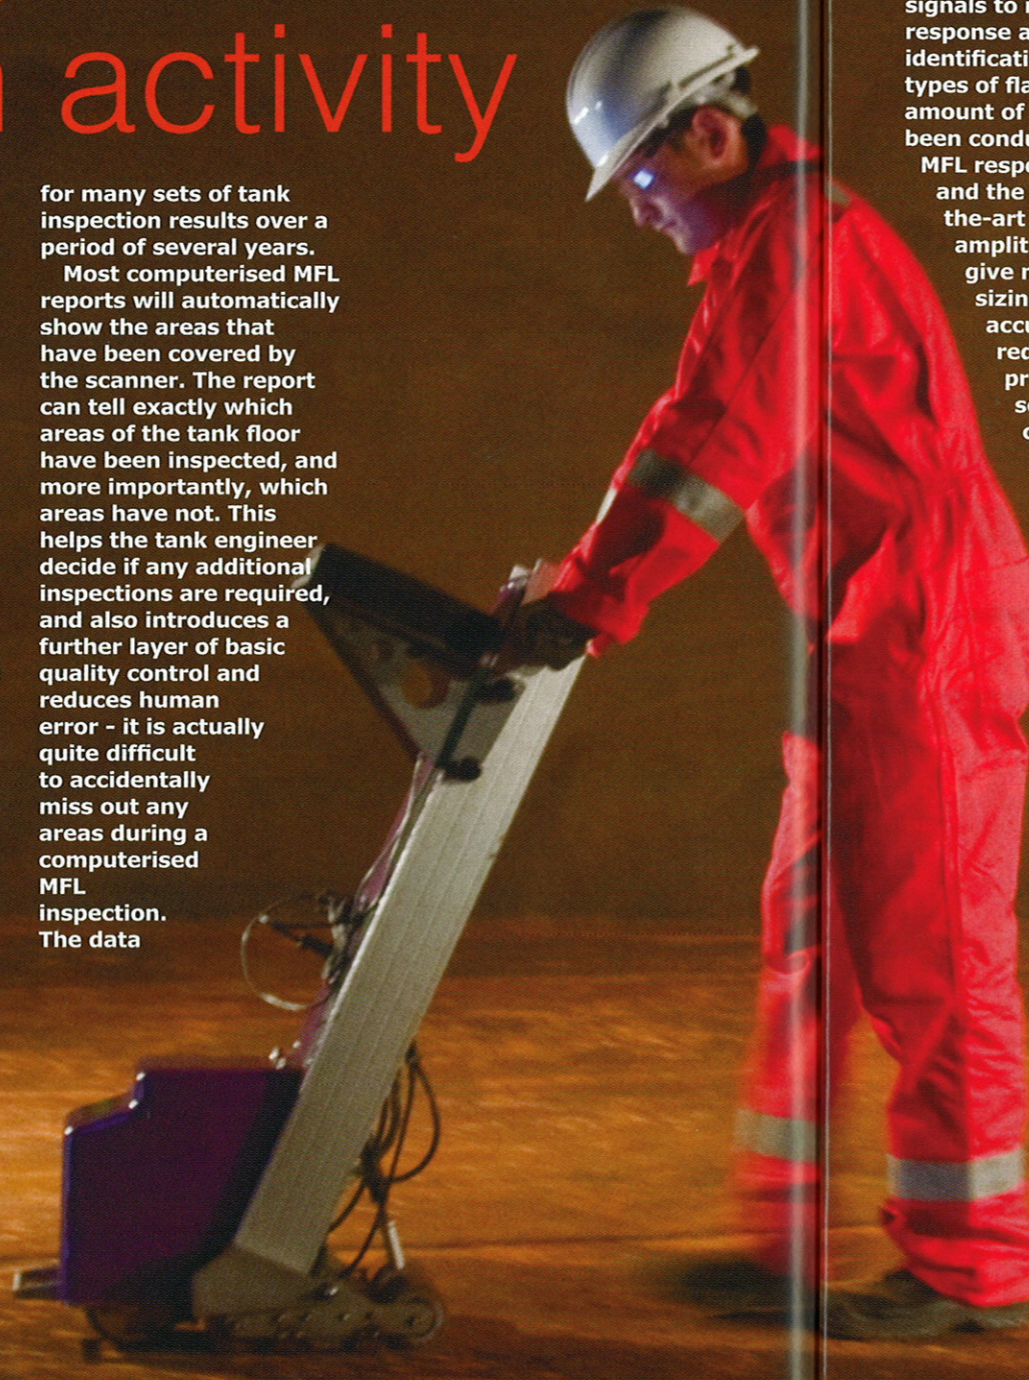
Tank floor mapping in progress

Most computerised MFL reports will automatically show the areas that have been covered by the scanner. The report can tell exactly which areas of the tank floor have been inspected, and more importantly, which areas have not. This helps the tank engineer decide if any additional inspections are required, and also introduces a further layer of basic quality control and reduces human error - it is actually quite difficult to accidentally miss out any areas during a computerised MFL inspection. The data

acquisition software will ensure that each plate is scanned in an efficient and methodical fashion. If any data is missing at the end of the inspection, the area will need to be scanned and the data included in the final report.

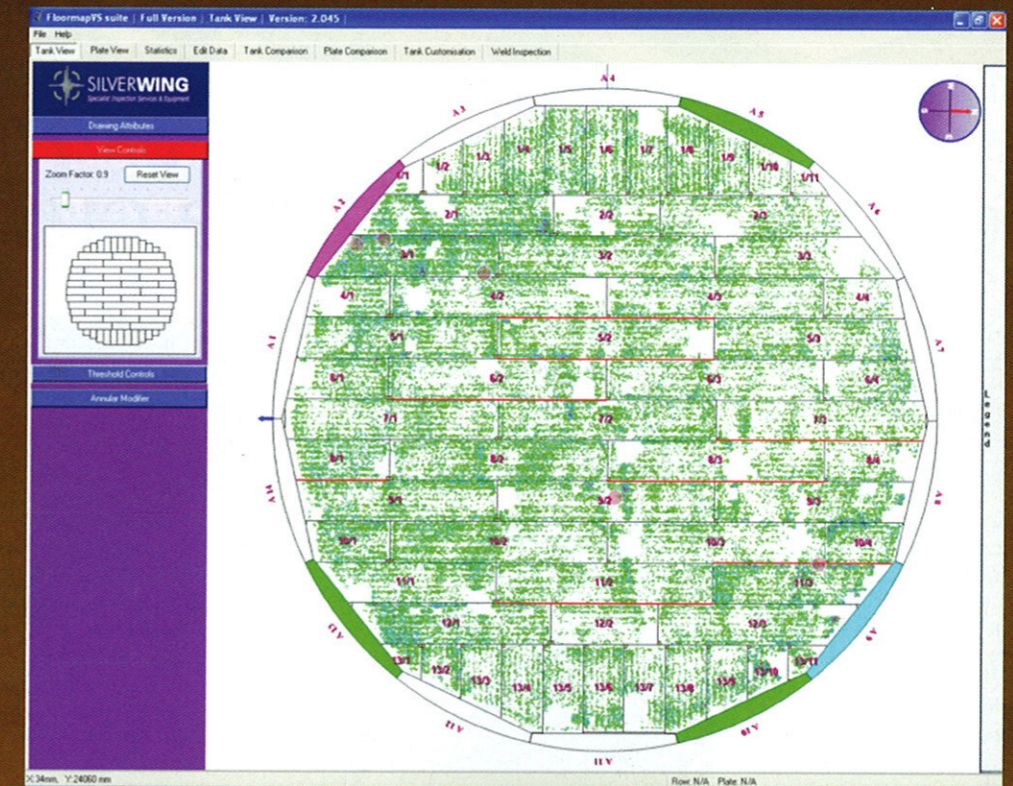
Tank floor with superimposed corrosion data. Plate layout can clearly be seen along with distribution of corrosion
