## TELETEST™ FOCUS+ IN PIPELINE INSPECTION AND ASSESSMENT APPLICATIONS

Eddyfi Technologies inspected and assessed the integrity of the Menzel Lejmat North (MLN) oil field 20.3cm (8in) and 30.5/45.7 cm (12/18 in) trunkline pipelines for ConocoPhillips-Sonatrach in Algeria.

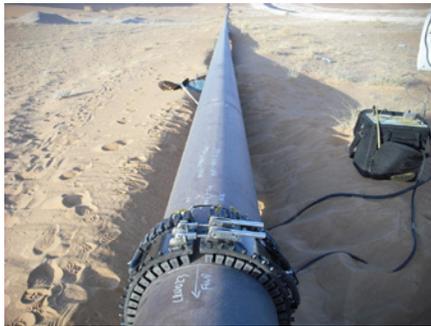
FOCUS+ guided wave ultrasonic test equipment used to inspect an 45.7cm (18in) trunkline of the MLN field in Algeria

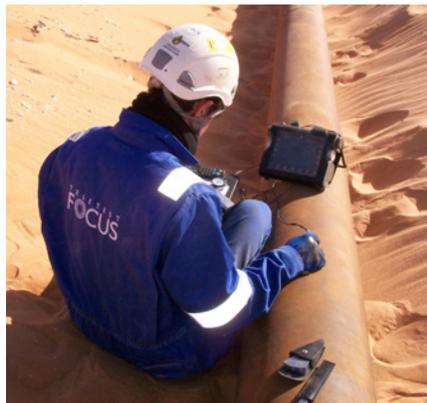
Ultrasonic wall thickness scans performed at FOCUS+ tool locations and at corroded areas to confirm internal corrosion was not present

Manual ultrasonic testing combined with profile pit gauging was used to confirm and size anomalies identified by the FOCUS+ screening inspections. These

follow-up inspections confirmed the presence of corrosion and sized the corroded areas at the required resolution for engineering assessment.

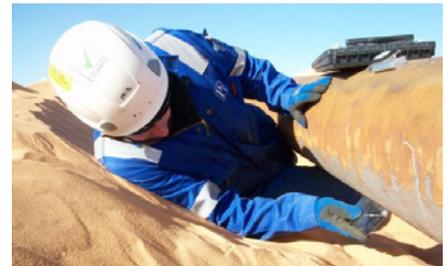
Characterizing external pitting corrosion using pipe pit depth gauges (lever type and dial gauge)

A fitness-for-service (FFS) engineering assessment was performed by integrity engineers, using the inspection results and relevant background data collected by the Teletest project team. The FFS assessment report estimated the remaining life of the lines based on the available information and identified areas requiring remedial action to achieve the desired minimum safe run length. The FFS assessment report also included recommendations for managing the integrity of the lines and for future inspections.
